# CAMP ROBERTS REAL PROPERTY DEVELOPMENT PLAN LONG-RANGE COMPONENT

# **ENVIRONMENTAL BASELINE**

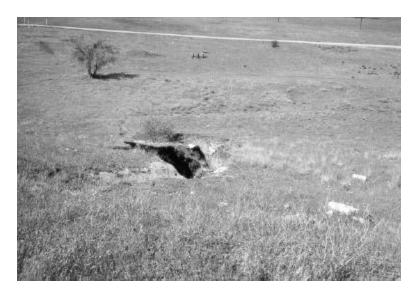
Photo 1 EROSION ALONG THE 7000 BLOCK

Erosion susceptibility on Camp Roberts is characterized as low to high. The level of erodibility is largely determined by the degree of slope. The areas most susceptible to erosion contain moderate to severe slopes and lie mainly in the impact area and southern portion of the camp. Since much of the project area is covered in pavement, on-site erosion is minimal. Underlying soils are considered to have slight to moderate erosion potential. However, the streams that drain the area off site are susceptible to higher erosion rates.

Soils do not impact the redevelopment of the main cantonment and East Garrison significantly. Good planning and design can overcome development limitations due to soil characteristics. Development may increase erosion in areas that are susceptible, especially the streams and natural drainage courses. Revegetation, check dams, or rock-lined streambeds would minimize erosion.

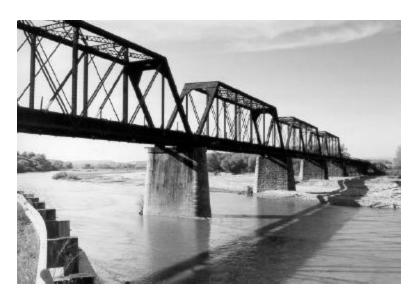
Photo 5 SOUTHERN PACIFIC RAILROAD BRIDGE

One bridge and the bridge remnant are not eligible for the NRHP. The third bridge has not been evaluated. The bridge is currently in use and maintained by Southern Pacific Railroad. This four-truss steel bridge was built in 1914 and clearly characterizes the historic Southern Pacific Railroad system that has been listed or determined to be eligible for listing in the NRHP. However, the bridge does not belong to the CAARNG and is not part of its preservation responsibility.

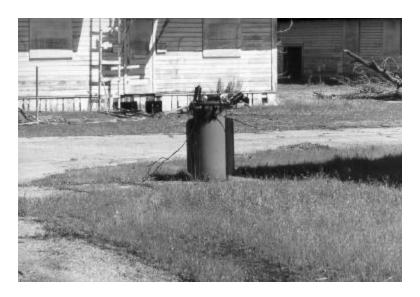
Photo 7
OLD TRANSFORMER CONTAINING PCBS

A number of activities on the main cantonment and East Garrison at Camp Roberts require the use of hazardous materials and the generation of hazardous waste. Activities include vehicle maintenance, facility and building maintenance, pest and weed control, and medical operations. Hazardous materials are used for operations at OMS #21, MATES, DFE, and the wastewater treatment plant. Hazardous waste includes PCB-containing transformers, asbestos, lead-based paint materials, pesticide containers, medical waste, solvents, and other hazardous fluids.

Demolition of the old structures will create a large amount of hazardous waste. Old transformers containing PCBs and old water heaters insulated with asbestos are considered a hazardous waste and require proper disposal. Additionally, the lead-saturated wood from the paint on the old structures is hazardous and requires proper disposal. There is a potential that the topsoil may contain hazardous levels of lead from paint and asbestos from insulation. The hazardous materials encountered during demolition will be disposed of properly by the contractor at the time of removal.

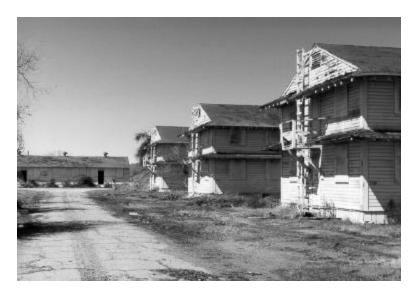
Photo 8
BUILDINGS SCHEDULED FOR DEMOLITION

According to the Environmental Office at Camp Roberts, there are no known buried hazardous materials in the main cantonment or East Garrison. However, the developed area has the potential to contain excessive amounts of lead and possible asbestos due to the dilapidating conditions of the buildings. The buildings were painted with lead-based paint and have asbestos in insulation around water heaters and pipes

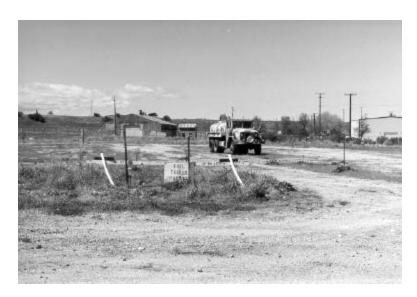
Photo 9 UNPAVED FUEL TANKER PARKING AREA

In addition to underground fuel tanks, heavy expanded mobility tactical truck (HEMMT) refuelers park on unpaved surfaces. This creates potential contamination to soil and groundwater.
